# Manhole Inspection Summary

Manhole # S45I2\_029MH

**Location** Address: **4612 Prudence St**

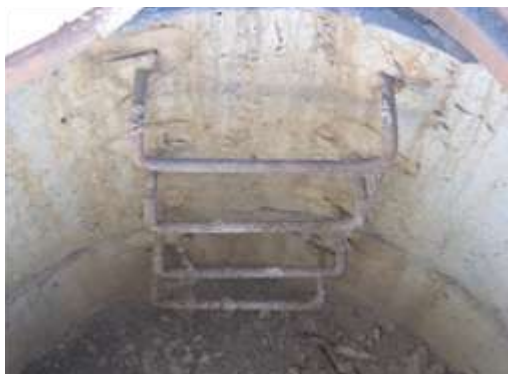
Steps

**Steps** Count: **4** Missing: **0** ☐ Corroded

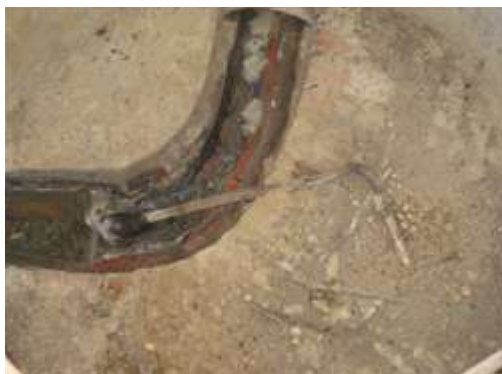
Defect 2

Debris

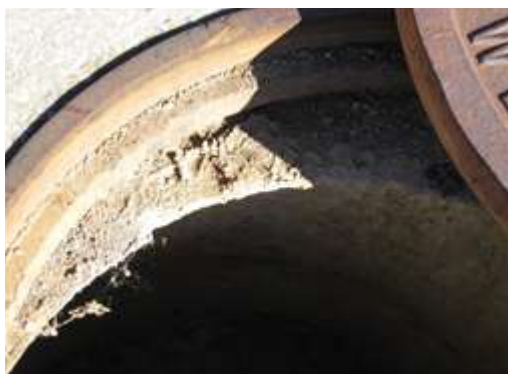
Defect 1

**Frame** Offset: **3** (in.) Condition: ☒ Sound ☐ Cracked ☐ Leaks

Frame offset

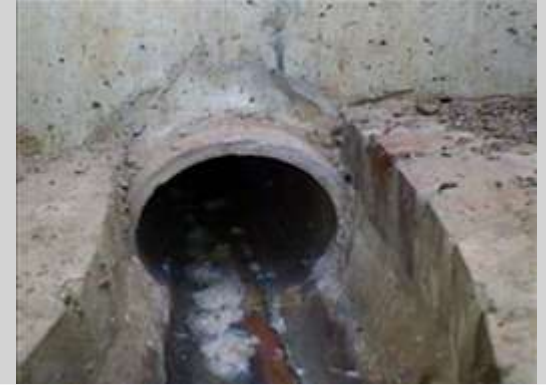
12 O'Clock Outflow

8 in. Circular Gravity Sewer  
Pipe Out @ 12 O'Clock

Pipe Height: **9.6** (in.) Rod and Bar (Angled)  
Pipe Material: **Clay** ☐ Pipe Lined  
Invert Depth: **6.27** (ft.) Flow Characteristics: **Slow**  
Deposits: ☒ None ☐ Mud ☐ Sludge ☐ Debris ☐ Grease  
Silt Depth: (in.) Deposits Extent:  
Infiltration: **None** Pipe Seal Cond: **Sound**

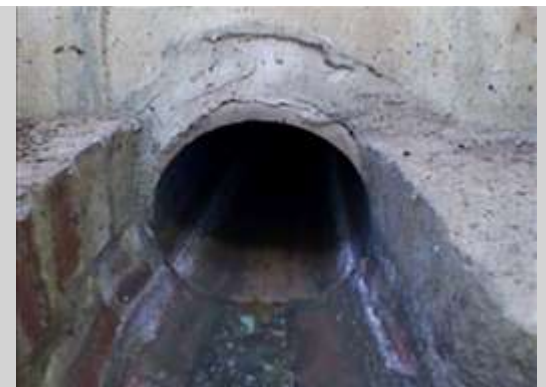
9 O'Clock Inflow

8 in. Circular Service Sewer  
Pipe In @ 9 O'Clock

Pipe Height: **9.6** (in.) Rod and Bar (Angled)  
Pipe Material: **Clay** ☐ Pipe Lined  
Invert Depth: **6.21** (ft.) Flow Characteristics: **Slow**  
Deposits: ☒ None ☐ Mud ☐ Sludge ☐ Debris ☐ Grease  
Silt Depth: (in.) Deposits Extent:  
Infiltration: **None** Pipe Seal Cond: **Sound**
